# The Mahurangi System

Leigh Lab Bulletin No 31.

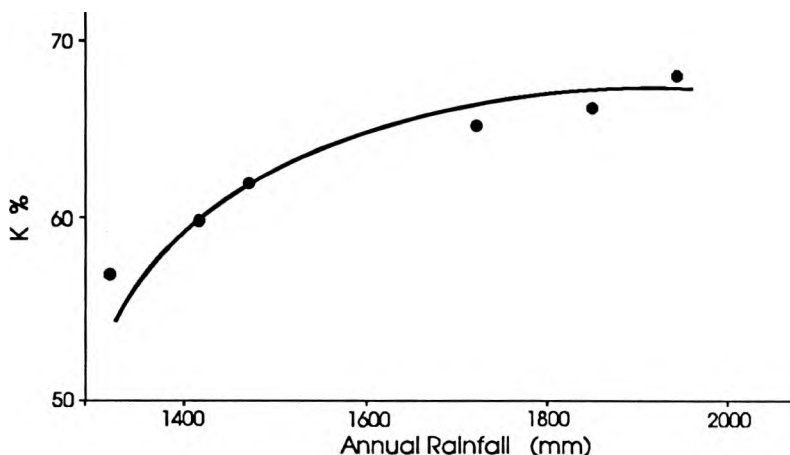
Change of average runoff coefficient ( $k$ ) with increasing annual rainfall ( $P$  in mm/year) averaged over 5 rainfall stations in or near the Mahurangi River Catchment for the years 1983-1989.

Another fact which inspection suggests is that a 50% runoff coefficient,  $k$ , while being suitable for low flows, is too low for wet years, when runoffs constitute nearer to two thirds of the rainfall. This point is illustrated in the graph which shows the way the average value of  $k$  varies with annual rainfall  $P$  (taken as an average of the total rainfall for the year at all five stations).

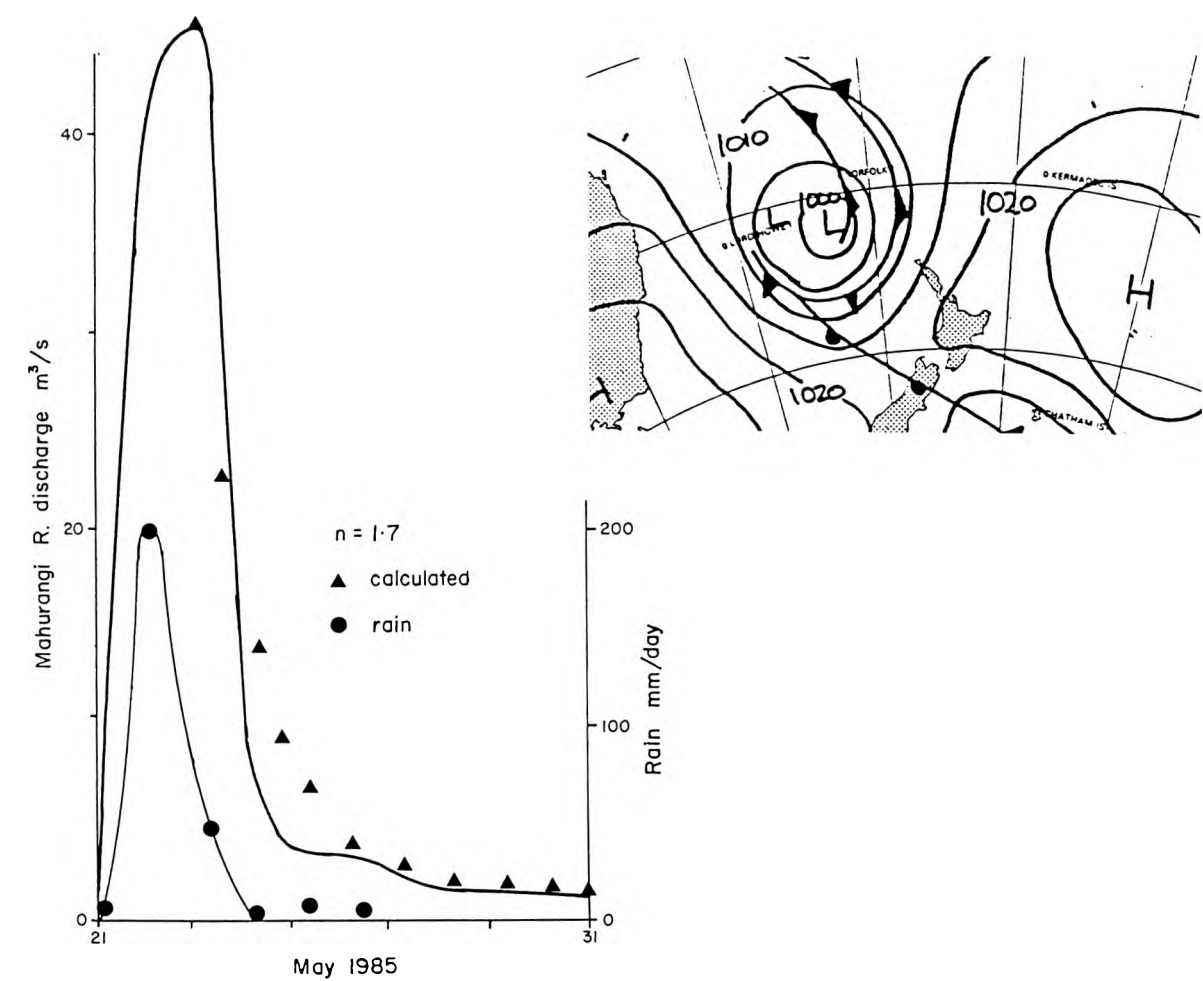
Response of the Mahurangi to rain. Example 1: Very heavy rain

The highest discharge in the Mahurangi River in the years 1982 to 1989 was 46210 litres /second or 46.21 m³/s, about 30 times the average flow and 100 times the initial base flow. It occurred on 23rd May 1985. The curve above (thick line) shows the rise and decay of the flood as well as the rainfall (thinner line with separate axis). The triangles are the computed river discharges with time after the peak of the flood using a value for  $n=1.7$  in the equation discussed above. The accompanying surface atmospheric pressure chart shows that the weather system responsible was a subtropical cyclone centred initially on Lord Howe Island in the Tasman Sea and a blocking high pressure region to the east towards the Chatham Islands. The resulting northeast winds blew over a warm sea fetch stretching from the Kermadec Islands, bringing in moist air and depositing 200mm on 22nd May. The run off coefficient for this event may have been as high as 75%.

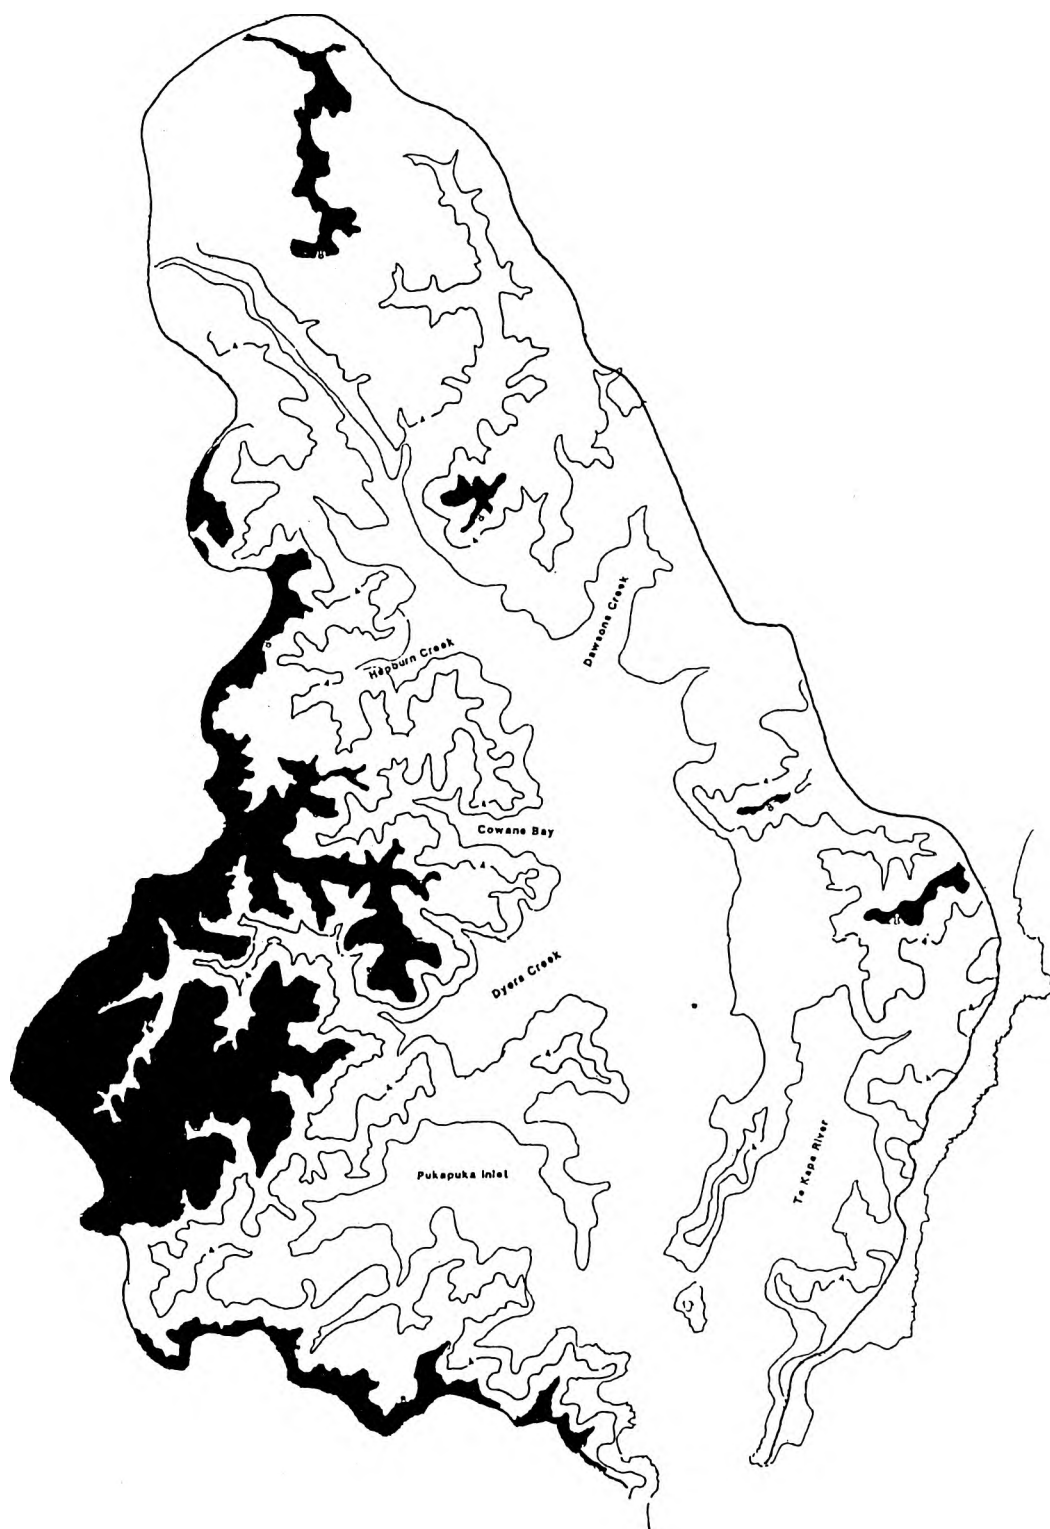
Height contours, drawn at 40m intervals, are marked, in units of 10m. Heights greater than 80m are black.

Johnston (1984) found a rock platform just below the surface of the mangroves, extending about 200m off-shore from Hamiltons Landing. It can be seen on the east bank. It seems possible that it is this platform which causes the river to veer sharply westward just up-stream of it.

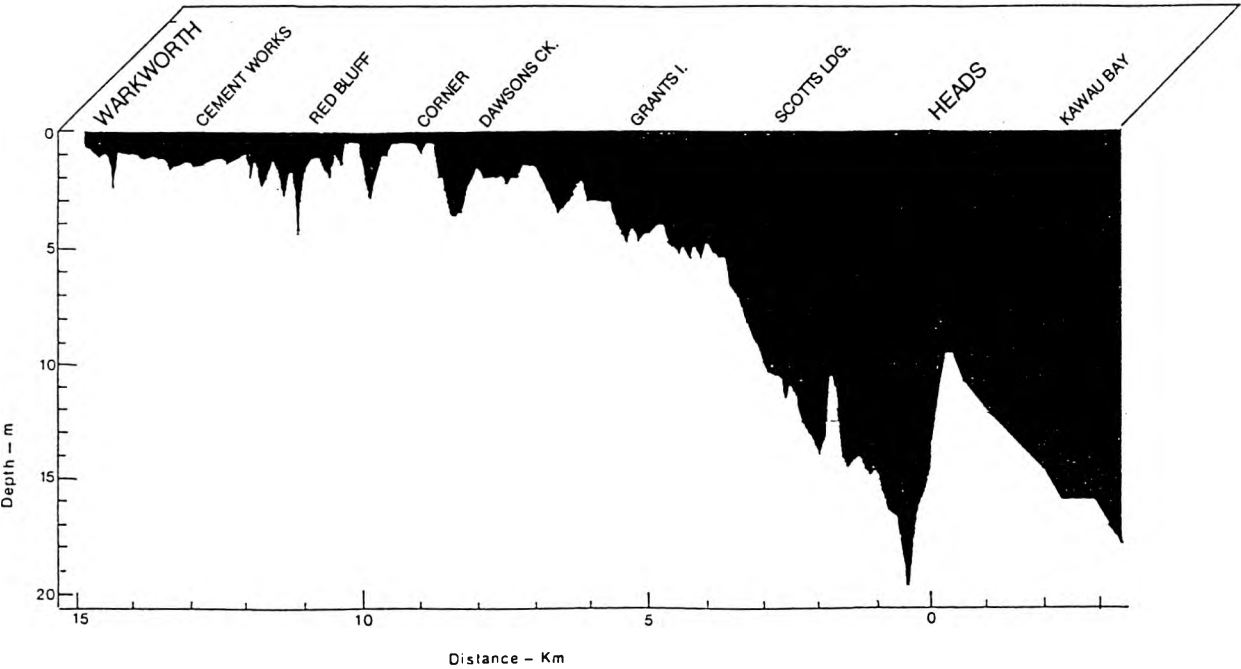
The water depths (referred to chart datum) up the axis of the Harbour range from 11m at the Heads to 1m off Dawsons Creek. Just inside the entrance there is a hole where the depths goes to 19m.

Profile of chart depths approximately along the axis of the tideway.

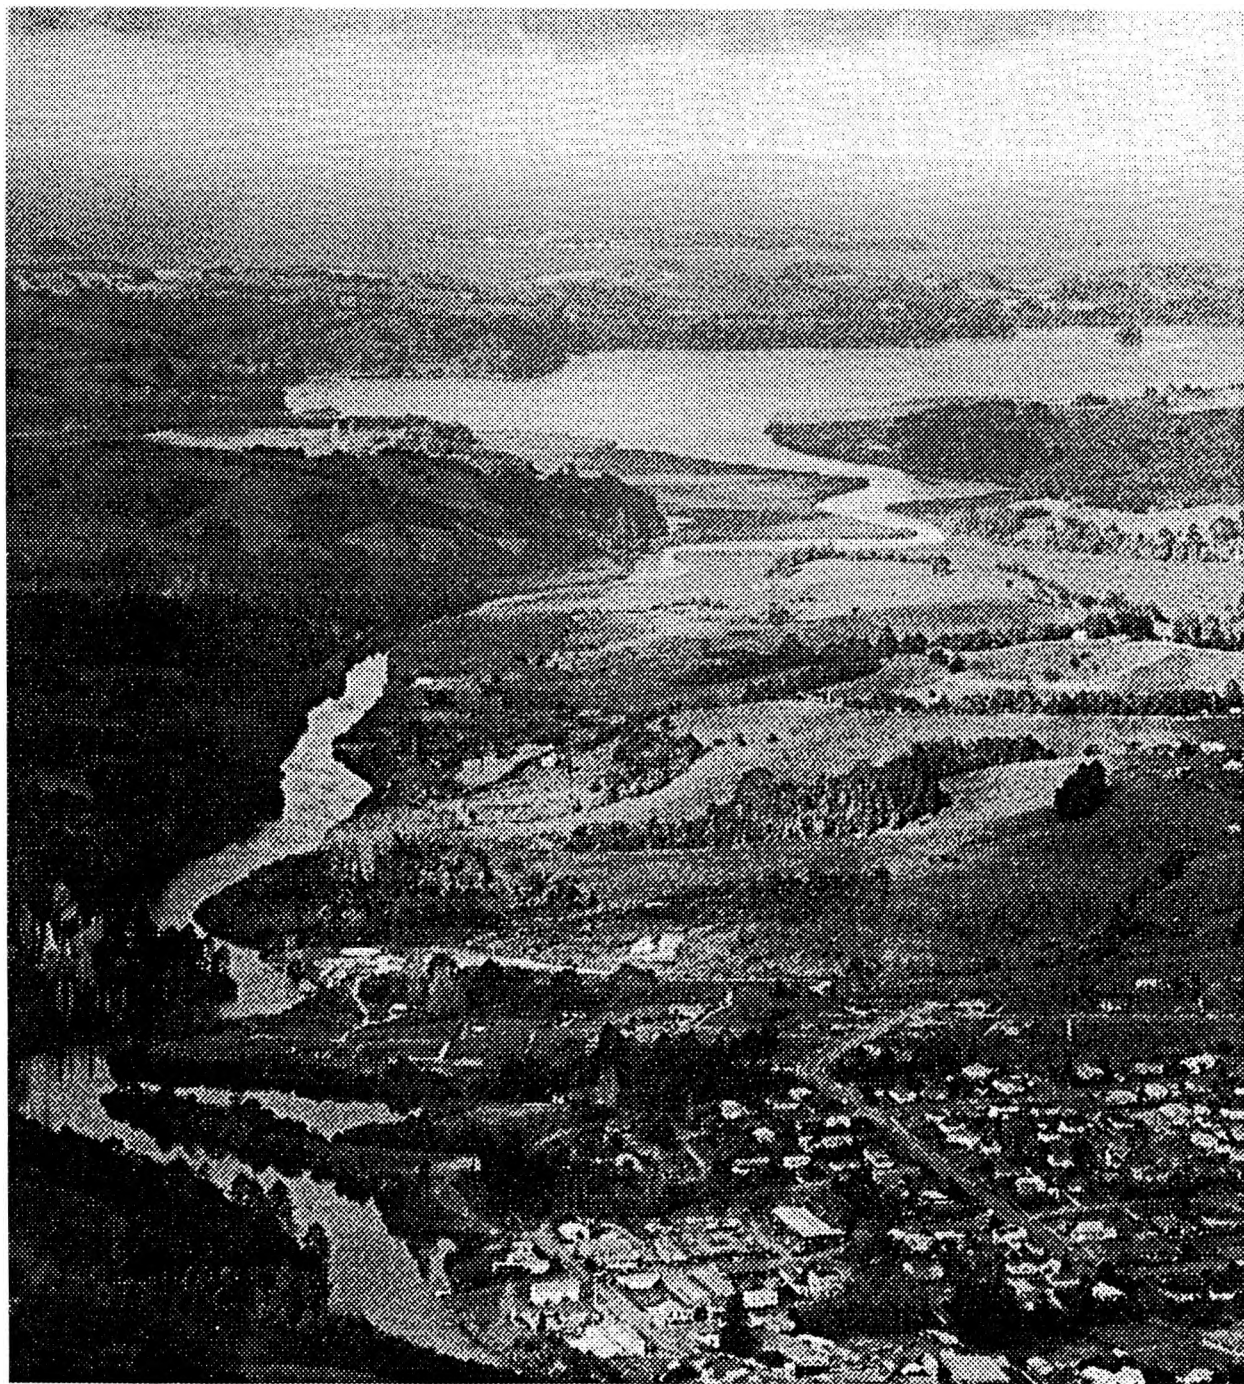
Taken from above Warkworth, this aerial photograph looks down the Estuary towards part of the much wider Harbour, with Grants Island just visible on the righthand side. The entrance to the Harbour, the Heads, is further to the right just out of the field of vision. Towards its junction with the Harbour, the Estuary supports extensive areas of mangroves.

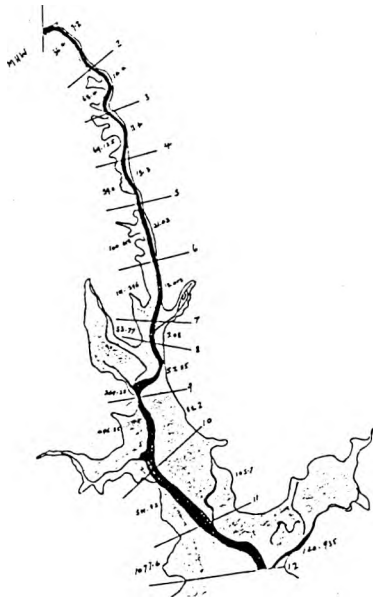
They are marked on the accompanying chart which shows the location of the cross-sections and also gives the high and low tide configurations of the Estuary.

High tide volumes are on the left and low tide volumes on the right, in units of  $10^3$  cubic metres.

Estimates of the volumes of water, at Mean Low Water (MLW) and Mean High Water (MHW), for selected reaches in the Estuary from Warkworth to Dawsons Creek, have been made, based on the areas of the cross-sections and the distances of the reaches between them.

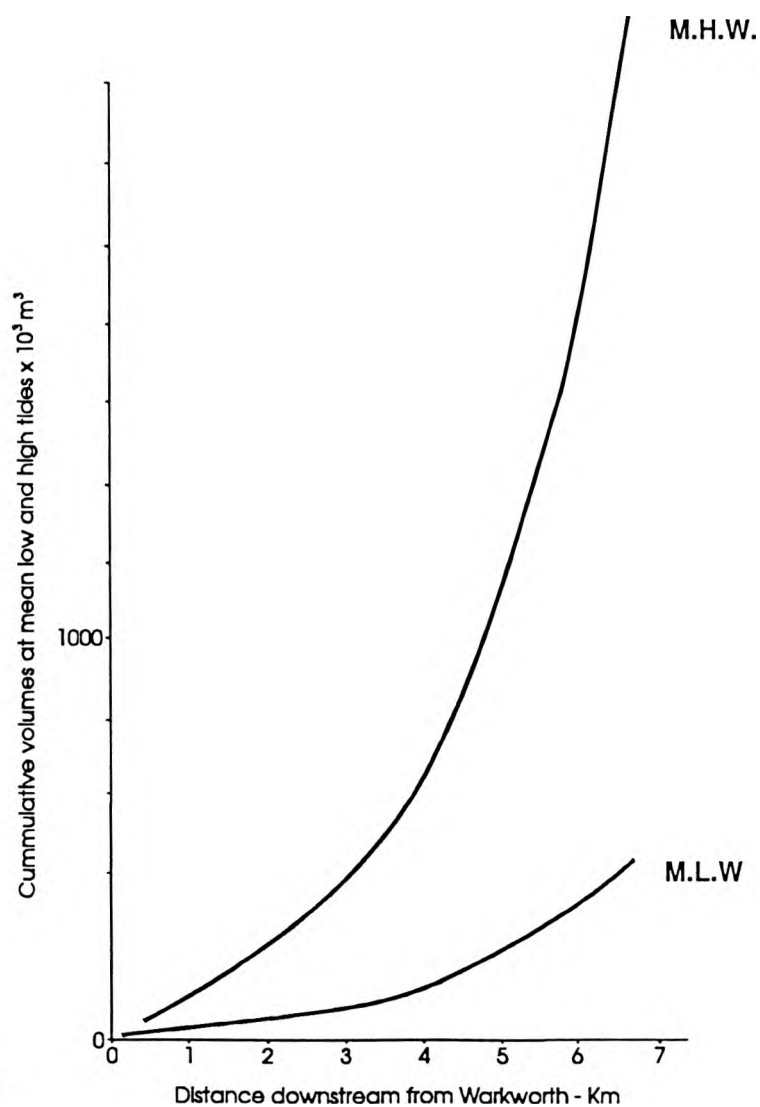
Graphs of the cumulative volumes in the Mahurangi Estuary with distance from Warkworth, at Mean High Water and Mean Low Water.

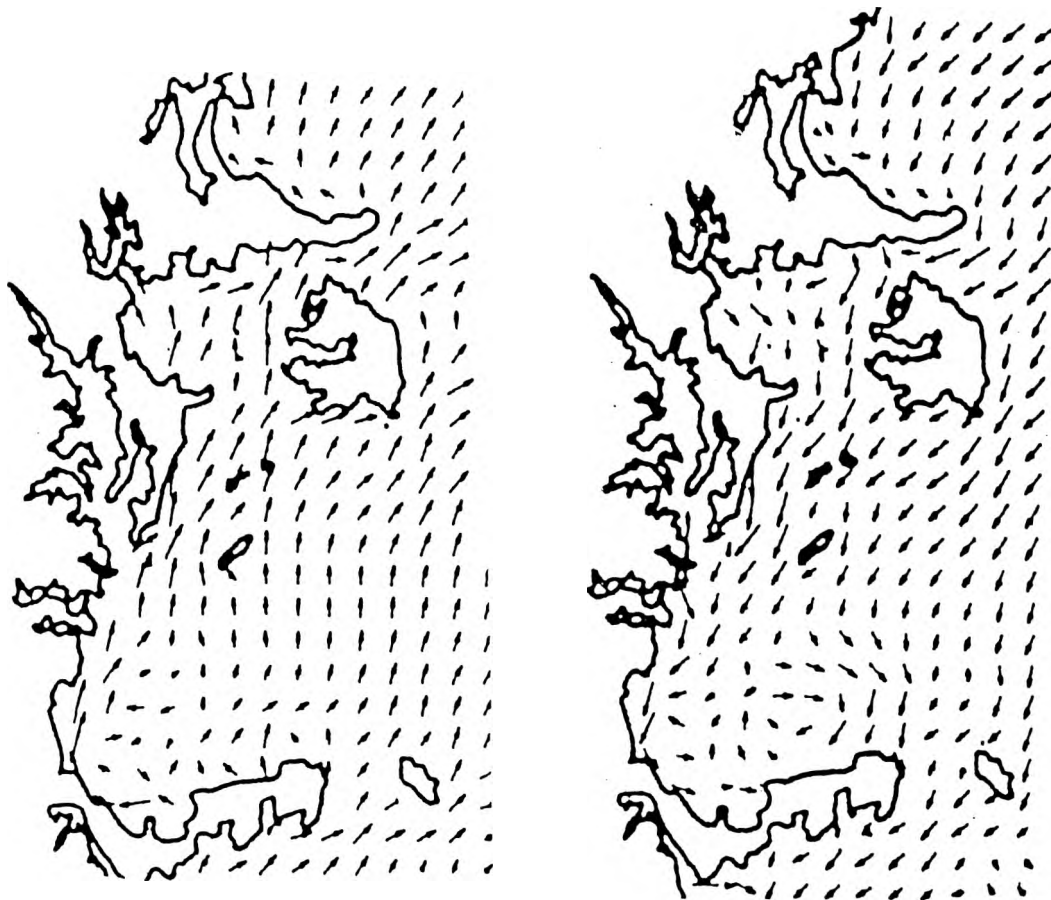
Current vectors of surface currents modelled for winds of 15m/s from, (left) the southwest and (right) the northeast. (After Proctor and Greig 1989).

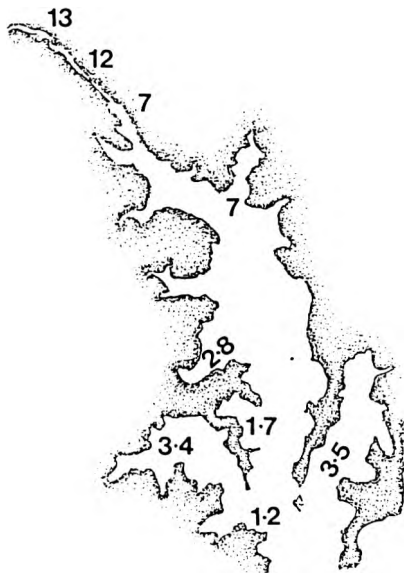
See diagram of Turbidity in NTU units (data from Feeney 1984). The fresh water inflow is sufficiently small and the harbour is sufficiently long for the influence of the clearer salt tidal water to ultimately dominate. There is therefore a range from turbid water introduced with the river waters. Additionally there is the turbidity introduced by wave and current turbulence in the shallower regions of the Estuary and Harbour (13 NTU) to clearer water in the deeper regions towards the Heads (2NTU), a tenfold decrease.

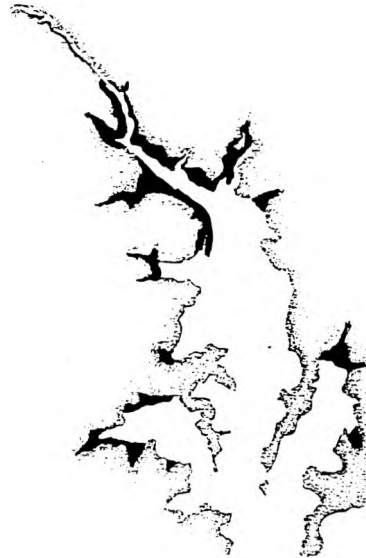
The mud-mangrove associated community, (marked black in the diagram) is a substantial part of the tideway; 23% of the area. It accounts for a major part of the food production and biomass in the Upper Waitemata Harbour.

Mangroves (*Avicennia marina*) thrive at the heads of creeks and along the banks of the Upper Harbour; and form an intertidal bush.

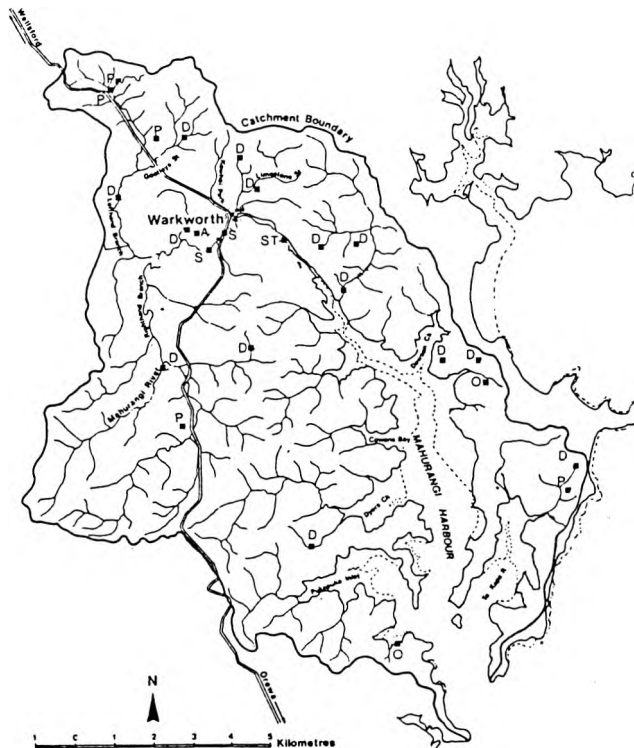
- P=piggery
- D=dairy shed
- O=oyster processing
- ST=sewage treatment
- S=swimming pool

Sites of major effluent sources (adapted from Feeney 1984).

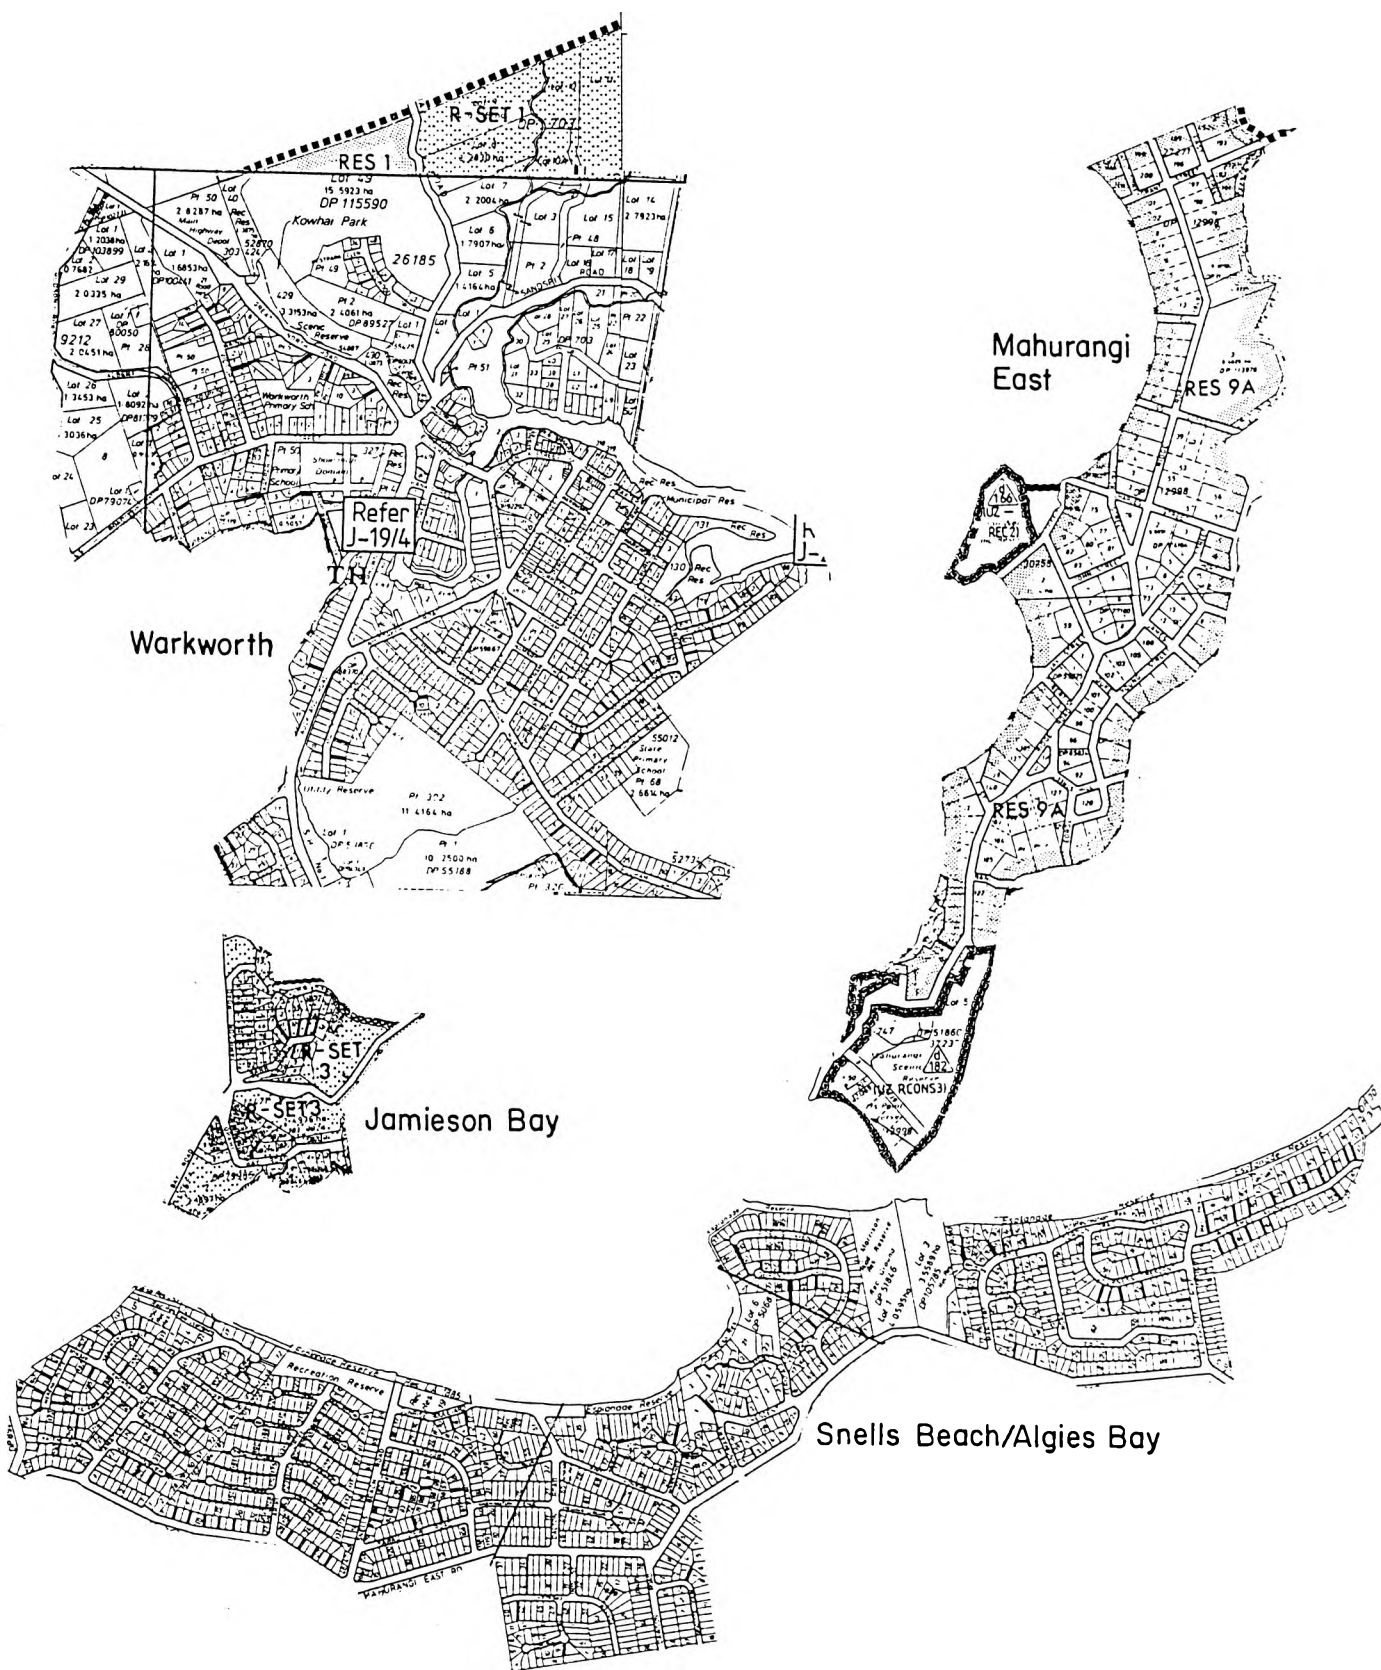
Built-up areas of Warkworth, Mahurangi East, Jamieson Bay, and Snells Beach/Algies Bay. (After Rodney District Council district scheme; proposed 1988)
